Nasca earthquake, November 12, 1996, Peru

J.E. Alva Hurtado & D. Vasquez Lopez
CISMID, National University of Engineering, Lima, Peru

ABSTRACT: The main features of the November 12, 1996 earthquake produced in the Nasca region in southern Peru are presented. A summary of damage evaluation and seismic microzonation undertaken by several national and international institutions is also presented.

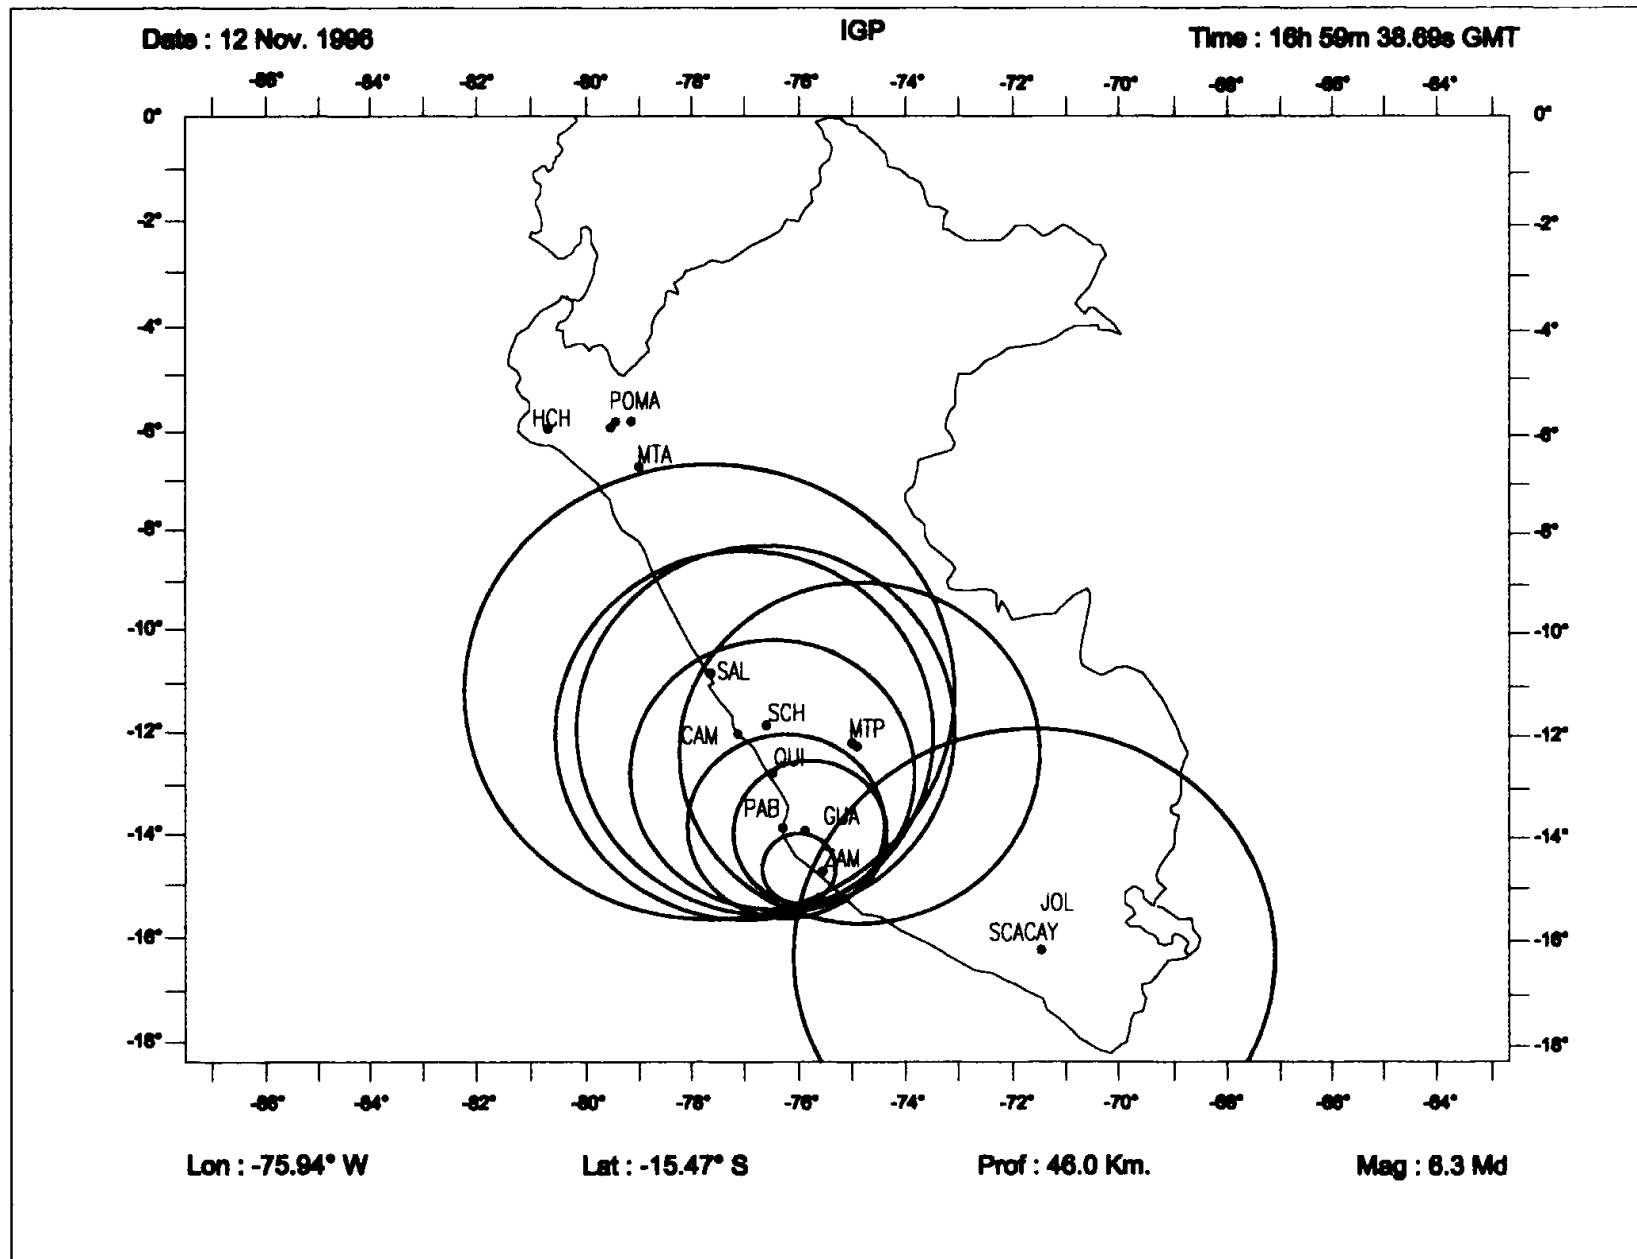
FIGURE N°1 : EPICENTER OF NOVEMBER 12, 1996 NASCA EARTHQUAKE (IGP, 1997)

The earthquake started at 11:59 a.m., local time, on the border between the Departments of Ica and Arequipa in southern Peru. The Geophysical Institute of Peru (IGP, 1977) calculated a magnitude of 6.3 based on duration of the earthquake (1'58"), with epicentral coordinates at 15.47°S and 75.94° W and a focal depth of 40 km. The corresponding USGS magnitudes are $m_b = 6.5$, $M_s = 7.3$ and $M_w = 7.7$, with a focal depth of 33 km and epicentral coordinates at 14.99°S and

75.68°W. Figure 1 presents IGP's epicentral calculation.
