## SEISMIC VULNERABILITY OF LIMA CATHEDRAL, PERU

### ABSTRACT :

This paper presents results of the earthquake response analysis of this building carried out within a vulnerability study made at the Japan-Perú Earthquake Engineering and Disaster Mitigation Center (CISMID).

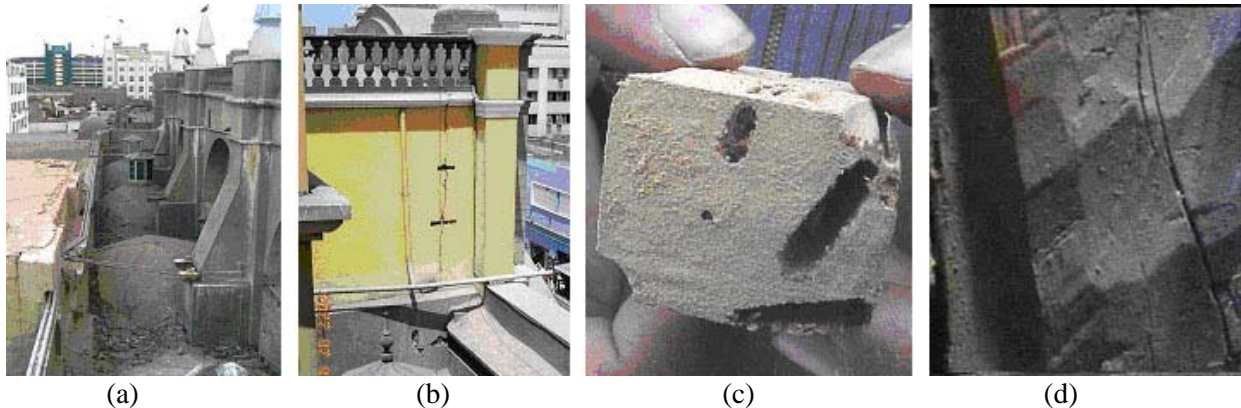
Figure 3 a) Poor maintenance of vaults and buttresses above chapels, b) Cracking in buttress at the crossing of the building, c) Biological attack in wood elements located between the vaults and roof framework d) Cracking in wood element above one pillar.

One of the most visible defects is the lack of verticality of the wood framed pillars. They have horizontal displacement in both directions, with values at the top ranging from 4cm to 15cm (in 13m) with maximum values in the central part of the building. There is no evidence of differential settlement in the walls.

Diagonal cracks were observed in the covers of most pillars. There is also visual evidence of deterioration and cracks in some of the wood elements located between the vaults and the roof framework structure. There is evidence of humidity and termite attack.

Most masonry walls do not have signs of distress, although the towers, the front walls and adjacent areas have always been affected in past earthquakes. However, there are important vertical cracks in the upper portion of the buttresses located in the crossing area of the building.

Successive reconstructions of Lima’s cathedral introduced important structural changes, which have reduced its seismic vulnerability, but not completely eliminated some structural deficiencies. One such deficiency is in the lateral stiffness of the roof, which is linked with the lateral displacement at the top of the pillars and the cracking of their plaster covers. The lack of adequate maintenance and the elimination of the flying buttresses have also resulted in a deterioration of the Cathedral’s seismic performance. An adequate plan to protect and replace some structural wood elements is necessary.

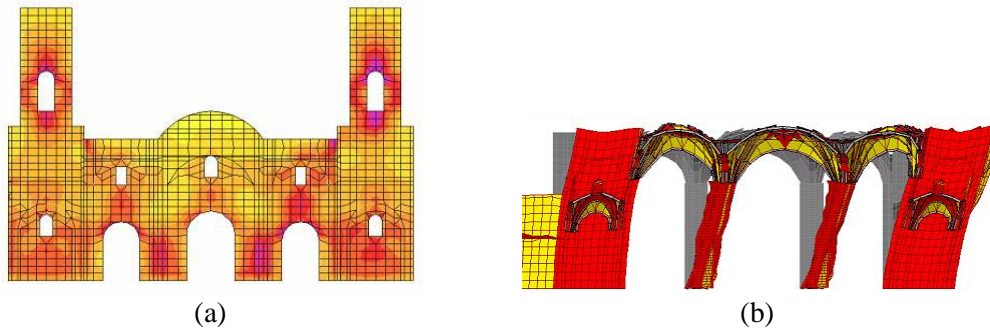
The towers of the cathedral are flexible (their fundamental vibration period being 0.6 seconds). The maximum shear stress will occur in the zone of the belfry, with values between 0.19MPa and 0.24MPa ( $2.0\text{kg/cm}^2$  and  $2.5\text{kg/cm}^2$ ). These exceed the capacity of the unreinforced masonry. As a matter of fact, the towers have been severely damaged in all major earthquakes in the past, affecting also the adjacent areas of the structure.

The front wall of the cathedral has its major weakness in out of plane direction. This wall is connected to the wood roof structure by four arches, located in pairs at the heights of 7m and 13m, which provide some lateral bracing. The analysis predicts an out of plane displacement of the order of 7cm for the design earthquake. The maximum in plane shear stress in this wall is 0.24MPa ( $2.5\text{Kg/cm}^2$ ).

Figure 6 a) Shear stress concentration in facade wall and towers b) Deformed shape of the structure due to earthquake component in transverse (X) direction.

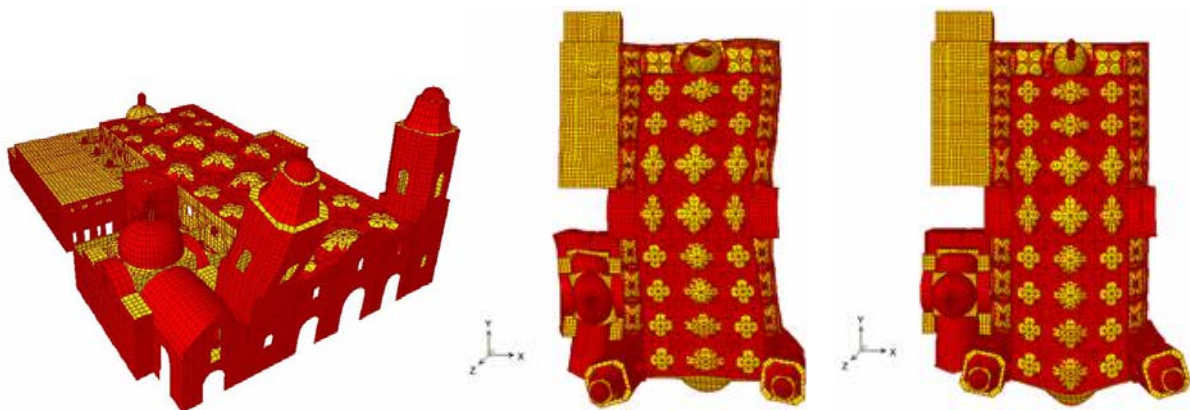
The buttresses in the crossing zone next to “Los Judíos” threshold are very flexible due to their considerable mass and 18m height. When treated as separate structures, these buttresses have a fundamental period of about 0.45 seconds, which is larger than the 0.39 s obtained for the complete building. This means that they do not effectively restrain the lateral displacement of the roof structure, but rather impair its performance.

Figure 7 Vibration modes: (a) 16<sup>th</sup> mode T=0.6s (b) 31<sup>st</sup> mode T=0.45s (c) 34<sup>th</sup> mode T=0.36s

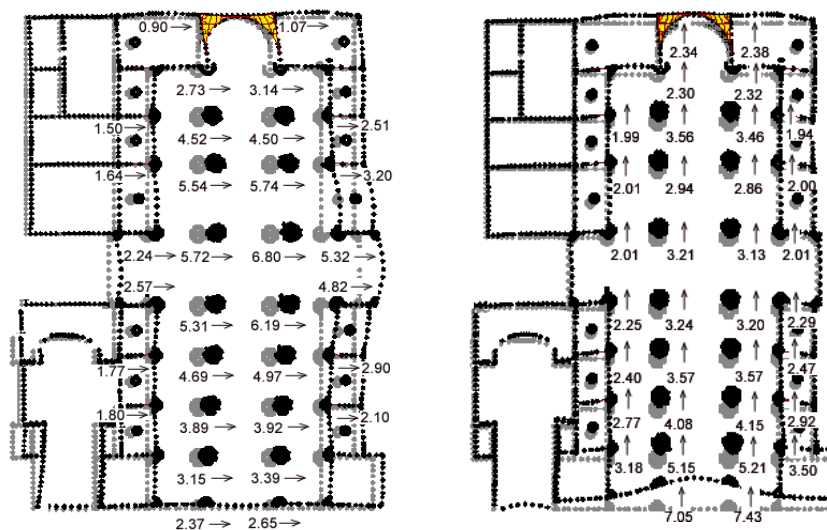
None of the analysis could completely explain the large horizontal displacements at the top of the pillars. The

analysis predicts maximum lateral displacements of 6.8cm in the area of the cruise and of 7cm in the facade wall, in the transverse (X) and longitudinal (Y) directions, respectively (see figure 9). The observed, permanent, maximum displacements are of the order of 15cm. They are obviously related with the insufficient lateral stiffness at roof level and most probably are the result of accumulated displacements, which were not completely corrected in successive reconstructions of the roof of the cathedral.

Figure 8 Lateral displacements at the top of the pillars due to earthquake components in transverse (X) and longitudinal (Y) directions.
