UNIVERSIDAD NACIONAL
DE INGENIERÍA

**CONFERENCIA INTERNACIONAL EN
INGENIERIA SÍSMICA**
Lima - Perú, 20, 21 y 22 de agosto del 2007

SEISMIC VULNERABILITY OF LIMA CATHEDRAL, PERU

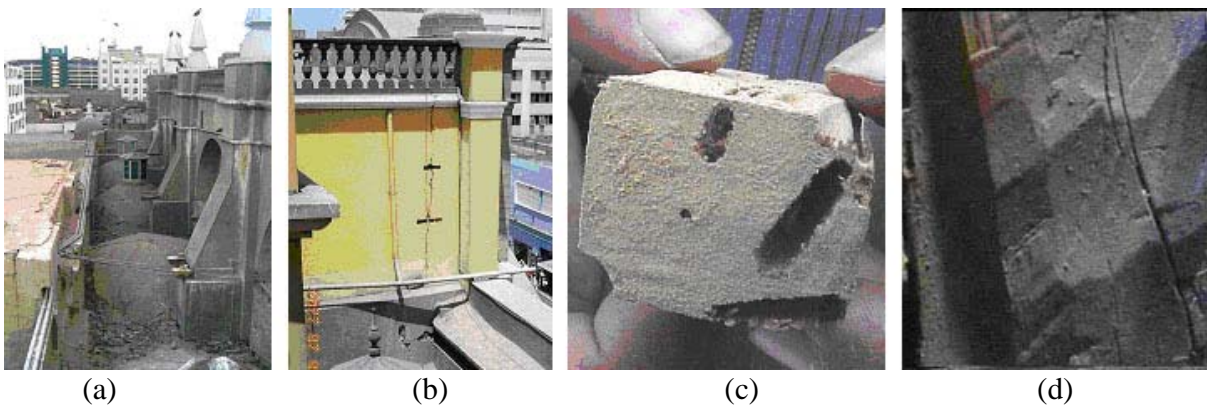
Figure 3. a) Poor maintenance of vaults and buttresses above chapels, b) Cracking in buttress at

the crossing of the building, c) Biological attack in wood elements located between the vaults and roof framework d) Cracking in wood element above one pillar.

Diagonal cracks were observed in the covers of most pillars. There is also visual evidence of deterioration and cracks in some of the wood elements located between the vaults and the roof framework structure. There is evidence of humidity and termite attack.

Most masonry walls do not have signs of distress, although the towers, the front walls and adjacent areas have always been affected in past earthquakes. However, there are important vertical cracks in the upper portion of the buttresses located in the crossing area of the building.

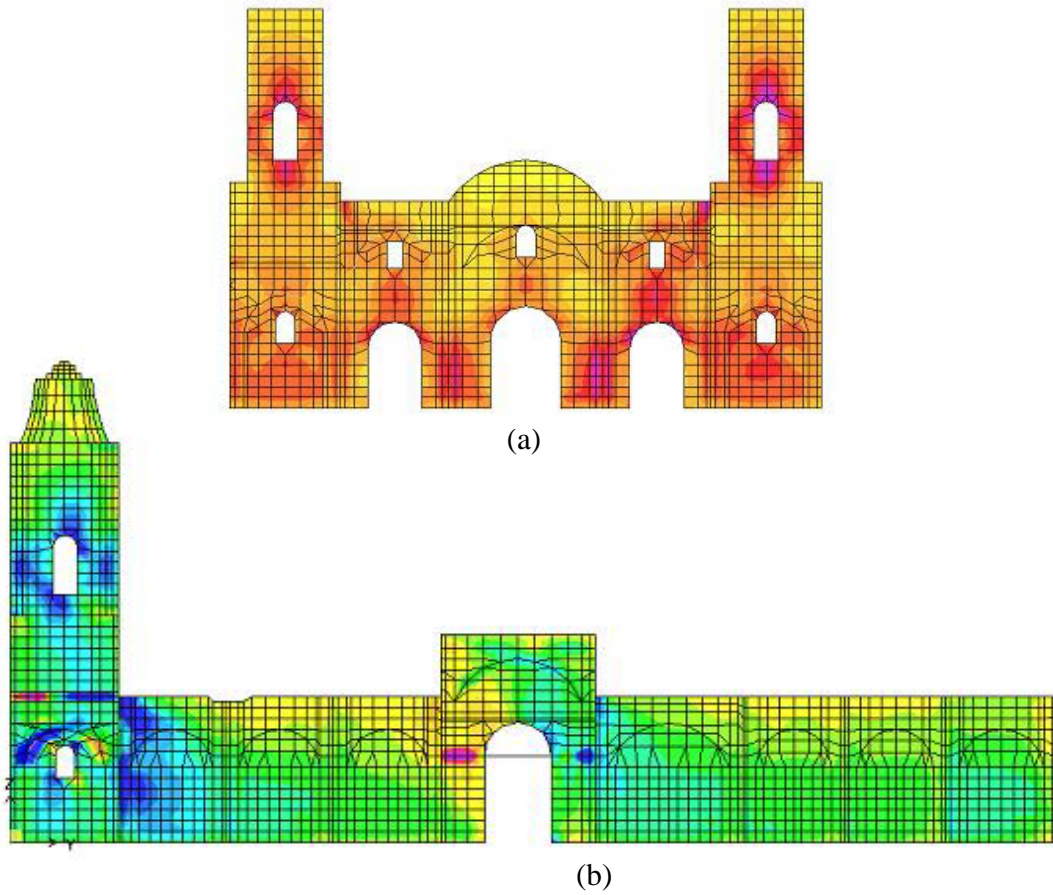
The towers of the cathedral are flexible (their fundamental vibration period being 0.6 seconds). The maximum shear stress will occur in the zone of the belfry, with values between 0.19MPa and 0.24MPa (2.0kg/cm² and 2.5kg/cm²). These exceed the capacity of the unreinforced masonry. As a matter of fact, the towers have been severely damaged in all major earthquakes in the past, affecting also the adjacent areas of the structure.

The front wall of the cathedral has its major weakness in out of plane direction. This wall is connected to the wood roof structure by four arches, located in pairs at the heights of 7m and 13m, which provide some lateral bracing. The analysis predicts an out of plane displacement of the order of 7cm for the design earthquake. The maximum in plane shear stress in this wall is 0.24MPa (2.5 Kg/cm²).

Figure 6. a) Shear stress concentration in facade wall and towers
 b) Shear stress concentration in a lateral wall.

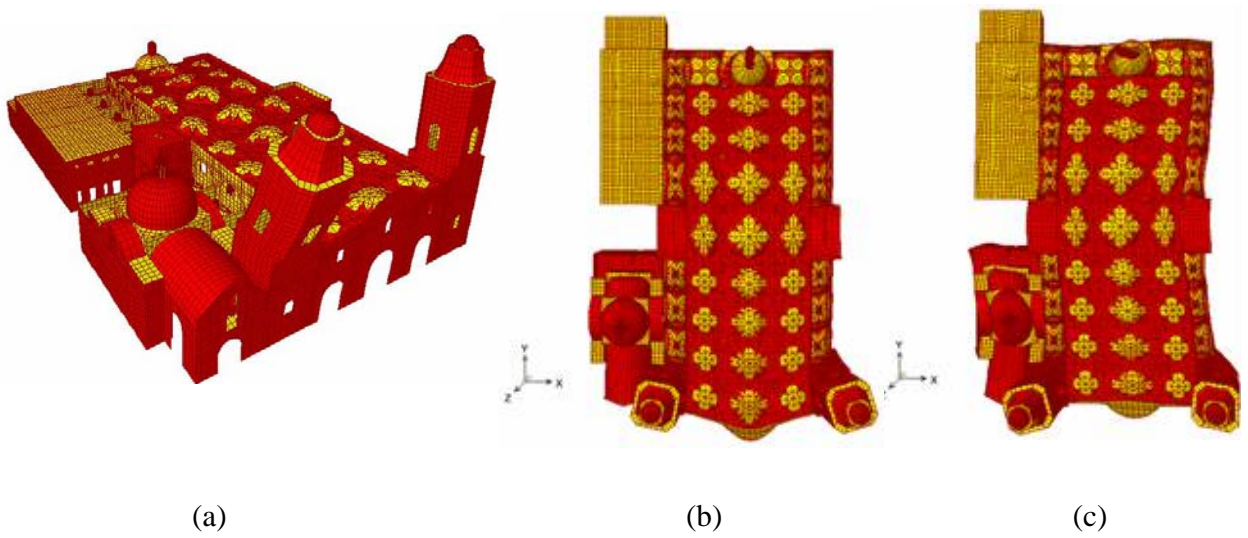
The buttresses in the crossing zone next to “Los Judíos” threshold are very flexible due to their considerable mass and 18m height. When treated as separate structures, these buttresses have a fundamental period of about 0.45 seconds, which is larger than the 0.39 s obtained for the complete building. This means that they do not effectively restrain the lateral displacement of the roof structure, but rather impair its performance.

Figure 7. Vibration modes: (a) 16th mode T=0.6s
 (b) 31st mode T=0.45s (c) 34th mode T=0.36s

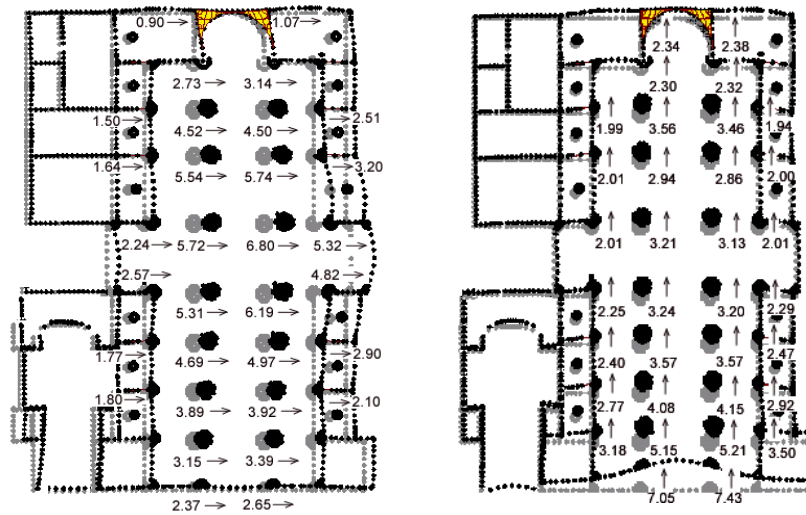
None of the analysis could completely explain the large horizontal displacements at the top of the pillars. The analysis predicts maximum lateral displacements of 6.8cm in the area of the cruise and of 7cm in the facade wall, in the transverse (X) and longitudinal (Y) directions, respectively (see figure 9). The observed, permanent, maximum displacements are of the order of 15cm. They are obviously related with the insufficient lateral stiffness at roof level and most probably are the result of accumulated displacements, which were not completely corrected in successive reconstructions of the roof of the cathedral.

Figure 9. Lateral displacements at the top of the pillars due to earthquake components in transverse (X) and longitudinal (Y) directions.
