**THE 1st JAPAN WORKSHOP ON ENHANCEMENT OF
EARTHQUAKE AND TSUNAMI DISASTER MITIGATION TECHNOLOGY
LIMA, MARCH 15-16, 2010**

**THE OBLIGATORY OFFICIAL TECHNICAL AUDITS
APPLIED DURING MORE THAN FIFTY YEARS FOR
THE EARTHQUAKE SAFETY ON THE CONSTRUCTION
OF SAN JUAN, ARGENTINA**

**Juan S. Carmona
Universidad Nacional de San Juan – Argentina
Profesor Honorario de la U.N.I. – Lima - Perú**

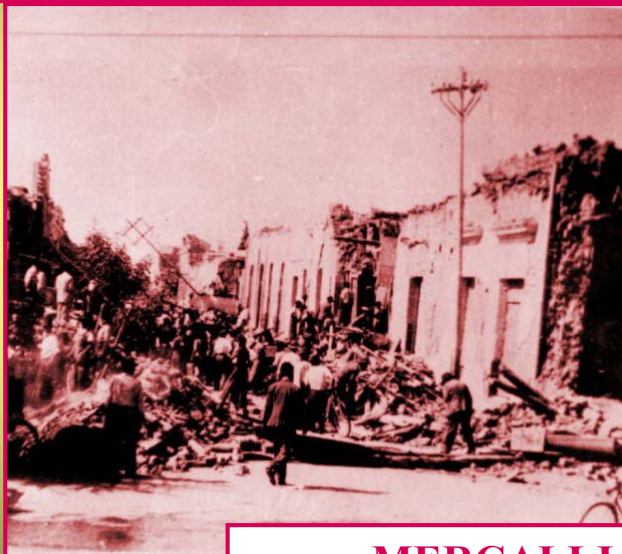
**GREAT DAMAGE ON THE CITY OF SAN JUAN, ARGENTINA,
8 a 10000 DEATHS , 15% OF ITS POPULATION
epicentral distance \approx 30 km**

MERCALLI INTENSITY: IX

EARTHQUAKE January 15, 1944- M=7,2

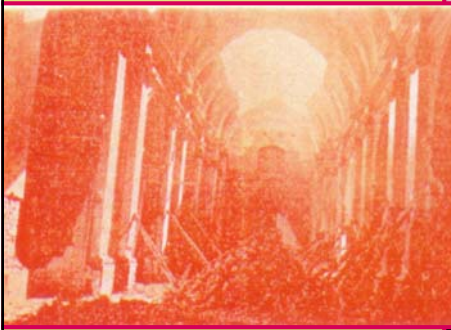
THE CATHEDRAL OF THE CITY OF SAN JUAN
epicentral distance ≈ 30 km

**THE INTERIOR AFTER
THE EARTHQUAKE**

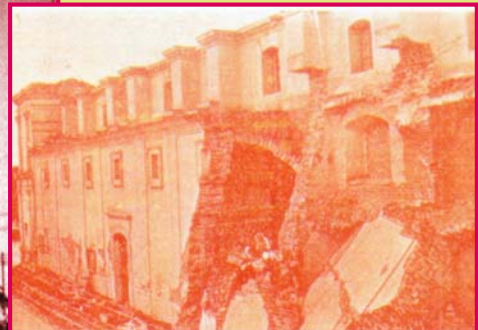
**PARTIAL COLAPSE
ON EXTERNAL WALL**

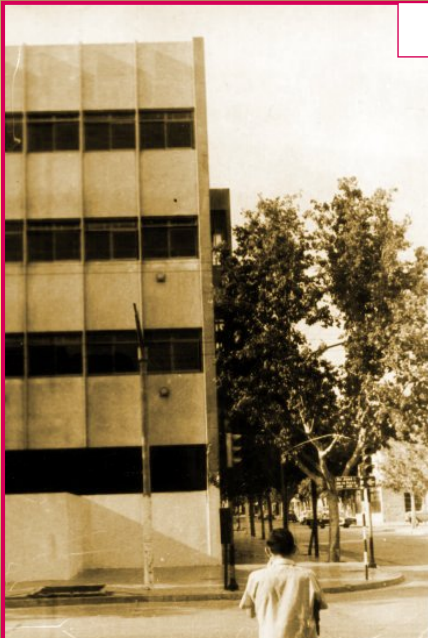
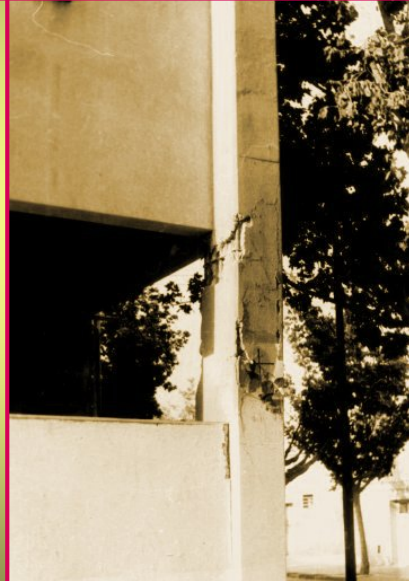
**CITY OF SAN JUAN - ENET N°4 BUILDING SCHOOL
FIRST FLOOR WITHOUT WALLS - IMPORTANT DAMAGE ON COLUMNS**

epicentral distance ≈ 60 km , IMM = VIII

LESSON LEARNED AND THEN INCLUDED ITS CONSIDERATION IN THE CODE

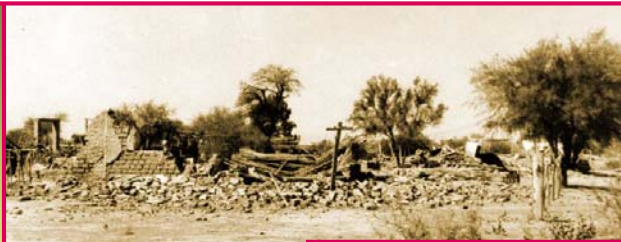
**THE TOTAL DESTRUCTION
ON ADOBE HOUSES SEVERAL
DEATHS CAUSED**

**BERMEJO TOWN
EPICENTRAL AREA**

IMM \approx IX - X

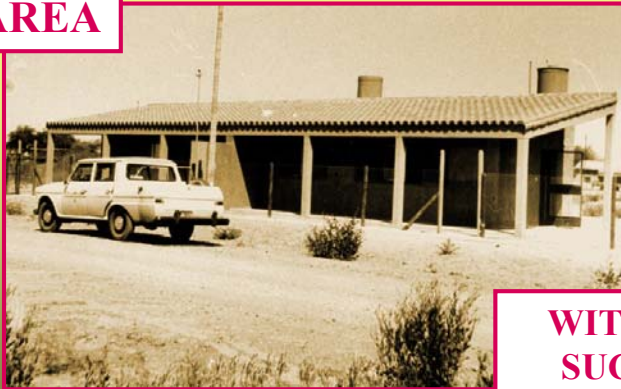
**WITHOUT DAMAGE,
SUCCESSFUL TEST**

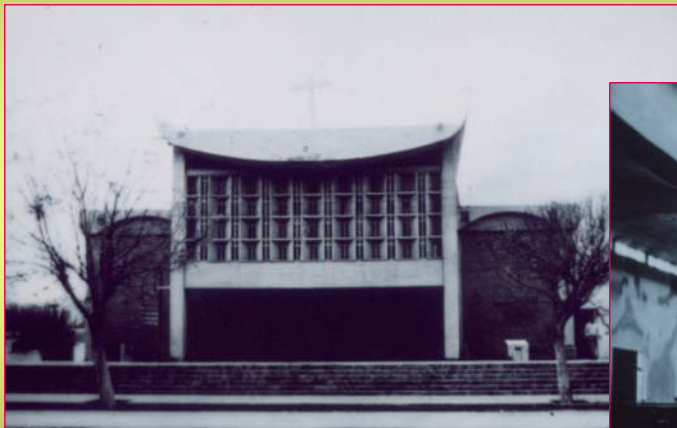
CRISTO REY CHURCH

ONLY MINOR DAMAGE

CAUCETE CITY
epicentral distance $\approx 30\text{km}$
IMM = IX

WILMOT SEISMOSCOPE
SA= 0,55g

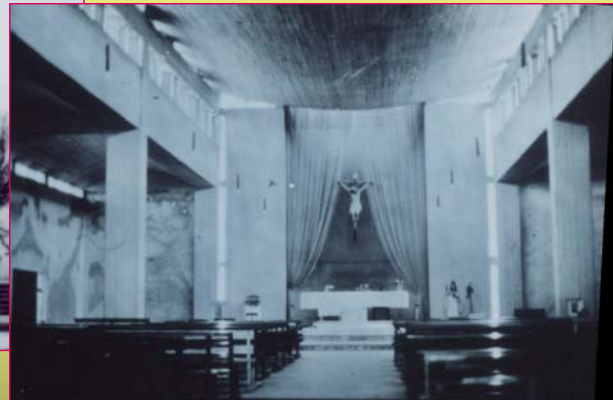
DESIGNED WITH HORIZONTAL FORCES FROM $C_s = 0,15$

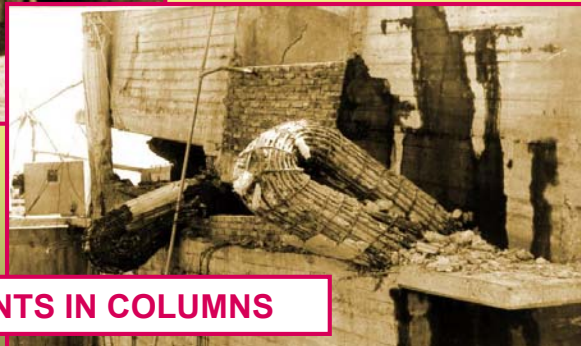
HIGH DENSITY OF STEEL REINFORCEMENTS IN COLUMNS

LESSON LEARNED AND THEN INCLUDED ITS CONSIDERATION IN THE CODE

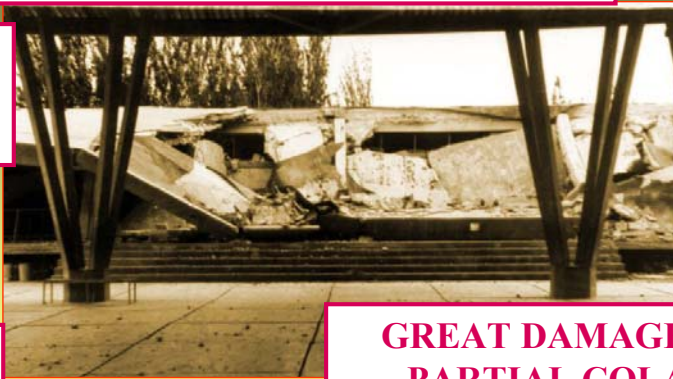
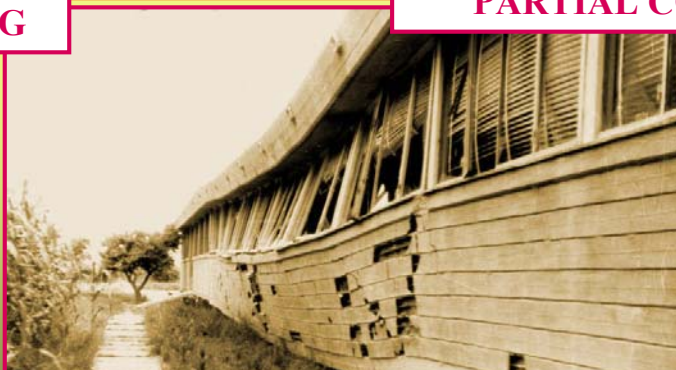
**“ESCUELA NORMAL”
SCHOOL BUILDING**

**GREAT DAMAGE WITH
PARTIAL COLAPSES**

BUILDING WITHOUT THE OBLIGATORY OFFICIAL TECHNICAL AUDITS

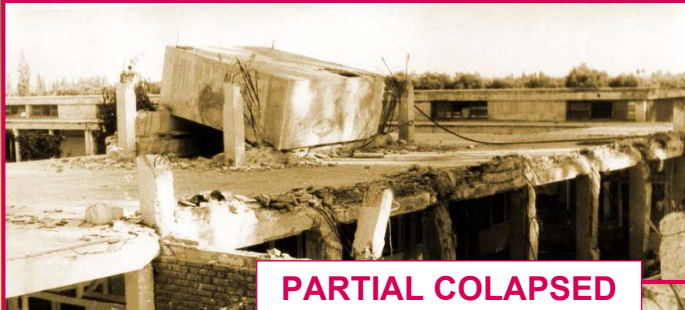
**“ESCUELA VIEYTES”
SCHOOL BUILDING**

PARTIAL COLAPSED

CAUCETE CITY
epicentral distance $\approx 30\text{km}$
IMM= IX- X

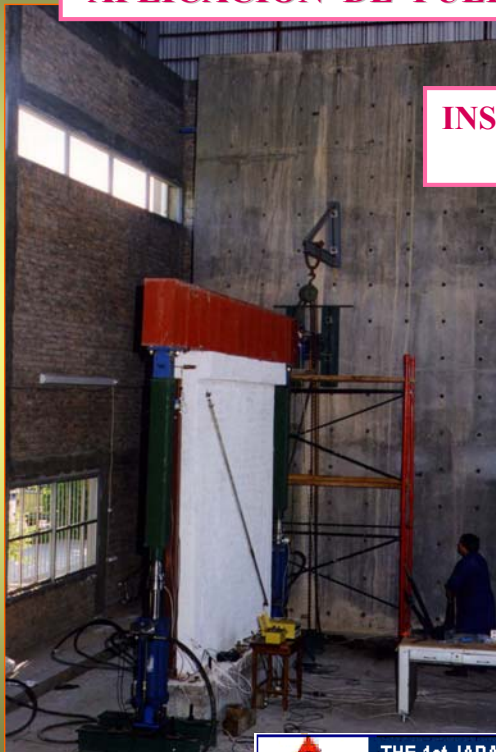
**ENSAYOS EN MURO REACTIVO
PANELES DE MAMPOSTERIA EN ESCALA NATURAL
APLICACIÓN DE FUERZAS HORIZONTALES ALTERNATIVAS**
