# International Conference on Earthquake Engineering

# History of Japan's Seismic Regulations and the New Damage Detection System

Koichi KUSUNOKI  
Vice-Director of Earthquake Research  
Institute,  
The University of Tokyo

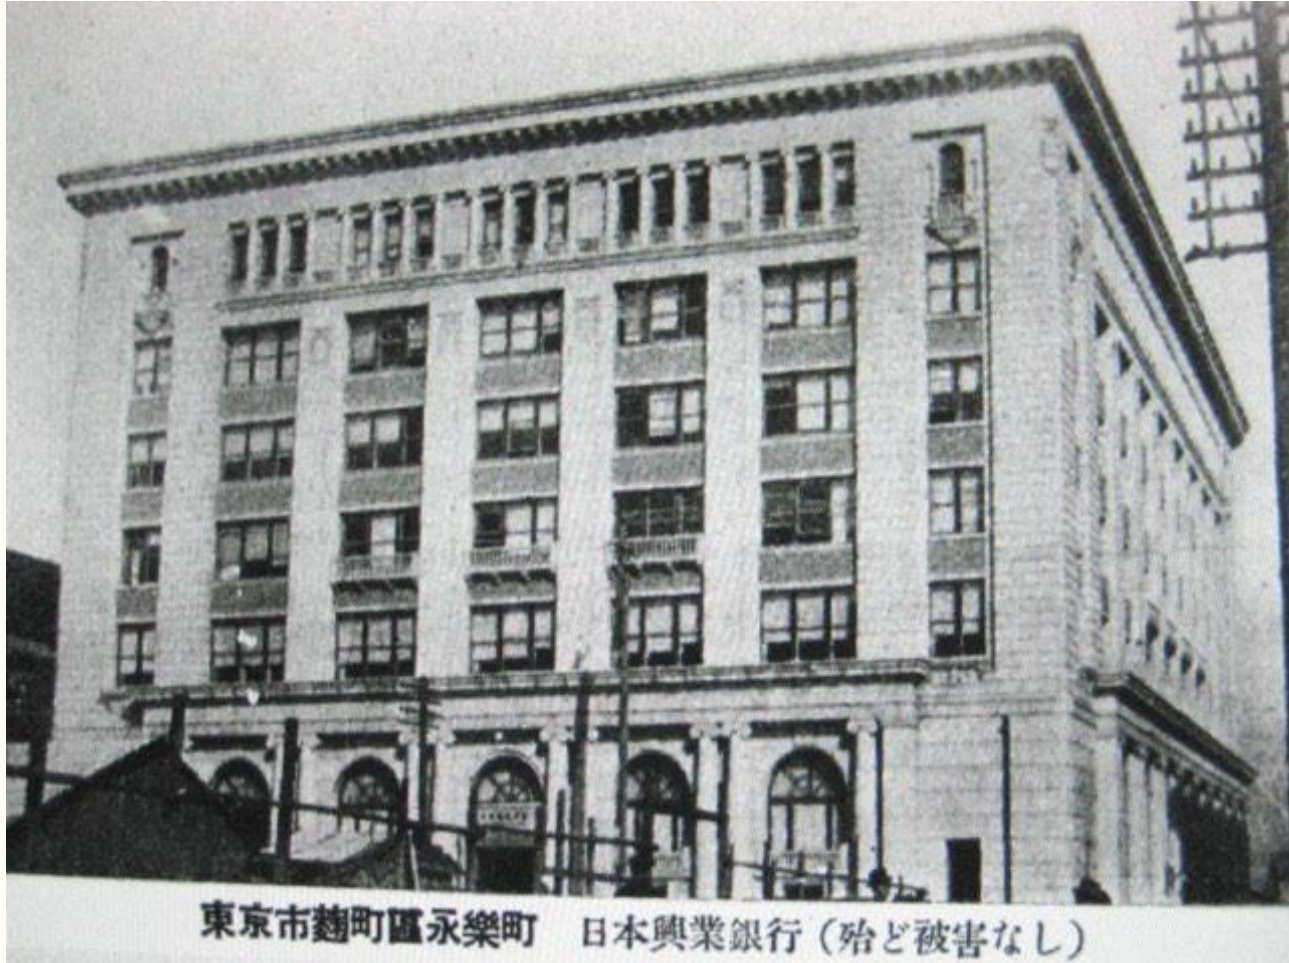
- Industrial Bank of Japan (1923)
- $C_B=0.067$
- Almost no damage

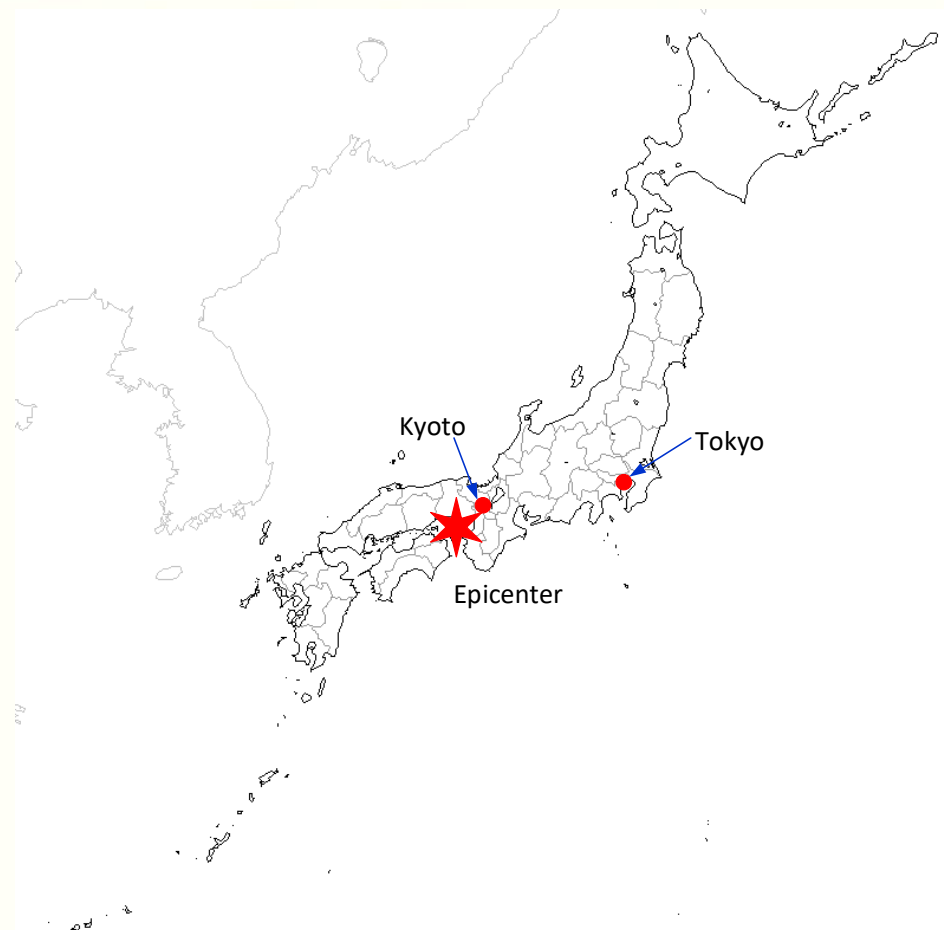
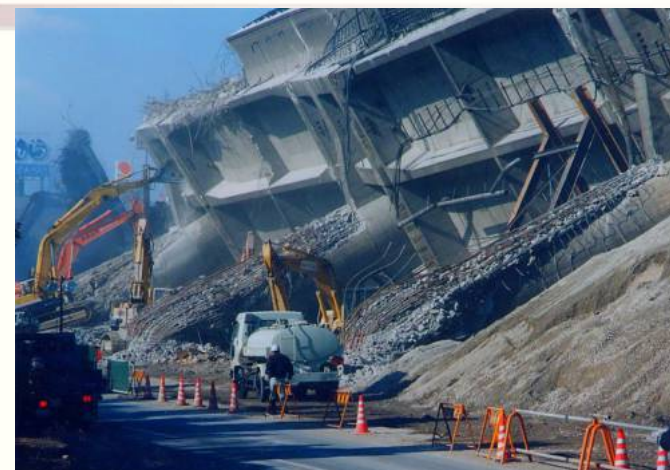
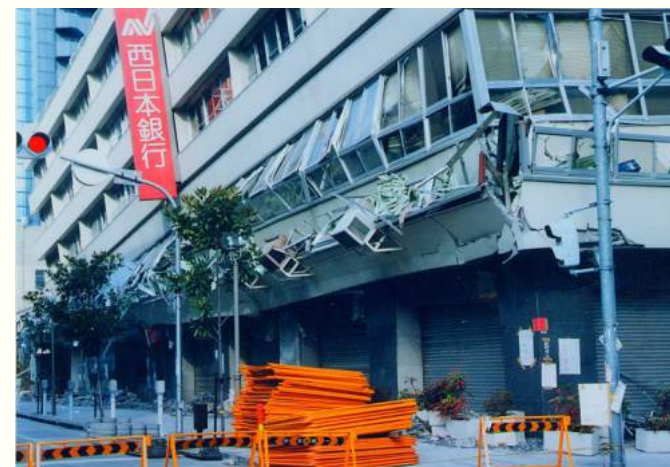
# Hyogo Ken Nambu Earthquake, 1995

- Occurred at 5:46, January 17<sup>th</sup>, 1995.
- The epicenter was Awaji Island.
- Magnitude was estimated as 7.3.
- Damage
  - Casualty: 6,434, Missing person: 3, Injured: 43,792
  - About 689,776 buildings were damaged.

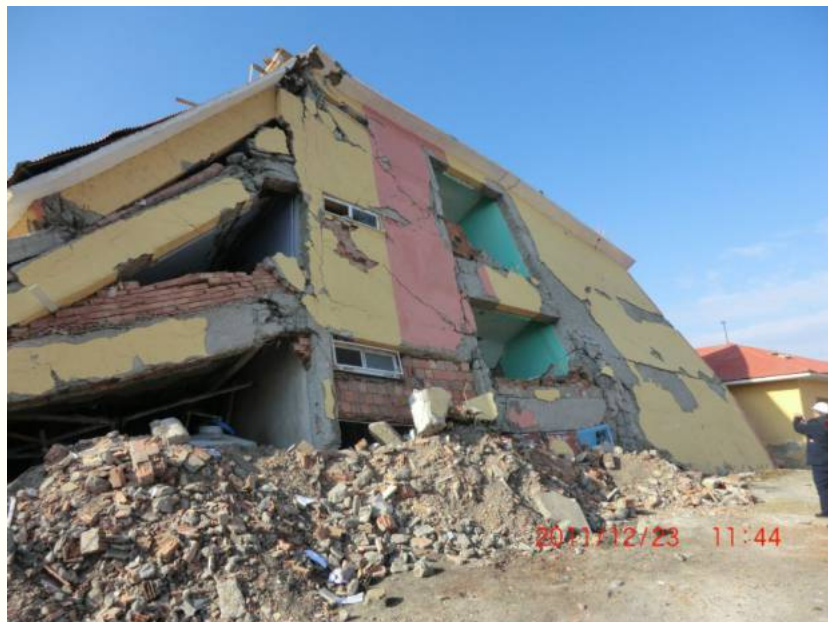
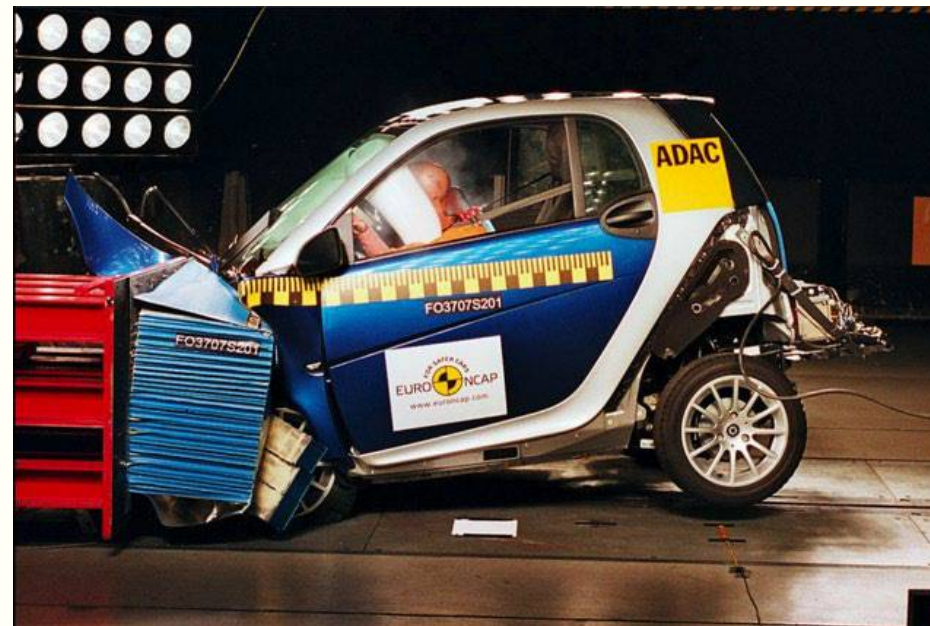
Building can dissipate earthquake energy by being “safely” damaged.

→ Ductile structure can reduce the demand

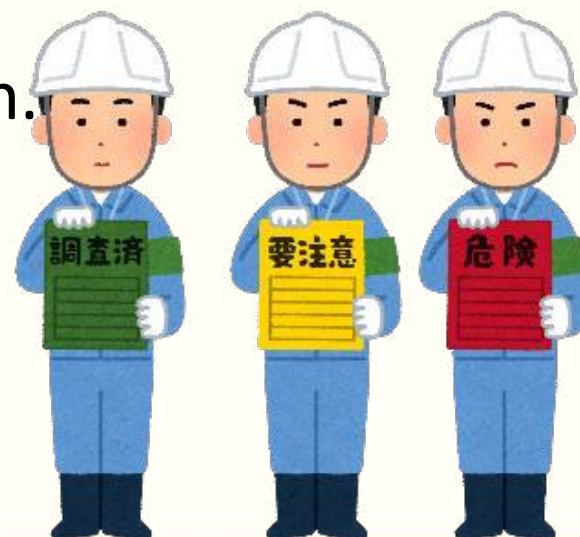
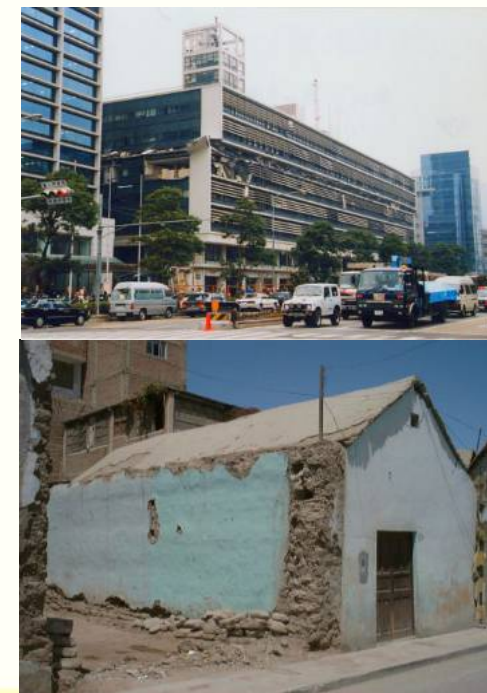
- Is your house, office, school, hospital, market, station, and etc. are safe to use continuously?
- We need to conduct the **Rapid Inspection** to evaluate the safety of the damaged buildings.
- It is based on the visual inspection.
- It takes time...

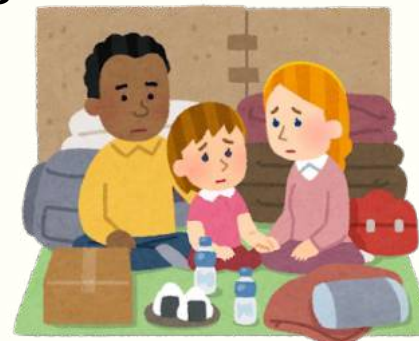
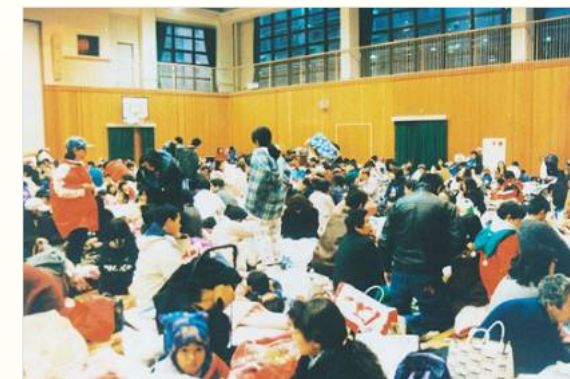
- It takes time
  - People need to stay at the shelters for long time.
- Many “Limited entry” judgements are made.
  - We need to evaluate the damage according to only residual cracks and inclination angle.

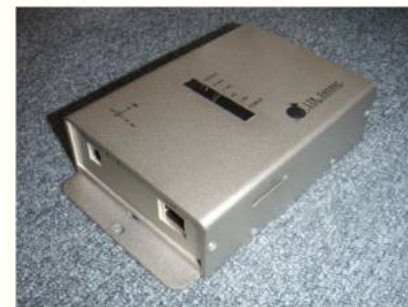
## Performance and demand curves are measured

Place few inexpensive accelerometers

Derive displacement from measured acceleration

Evaluate by comparing these curves

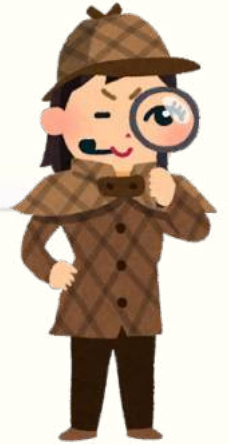
Put sensors to evaluate the damage based on the capacity spectrum method.

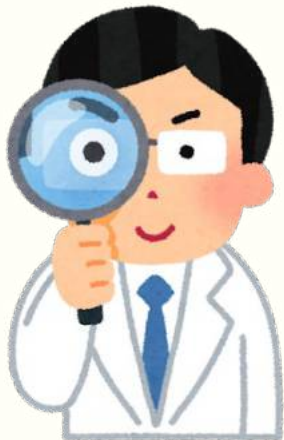
- Damage evaluation is conducted according to the Japanese standard.

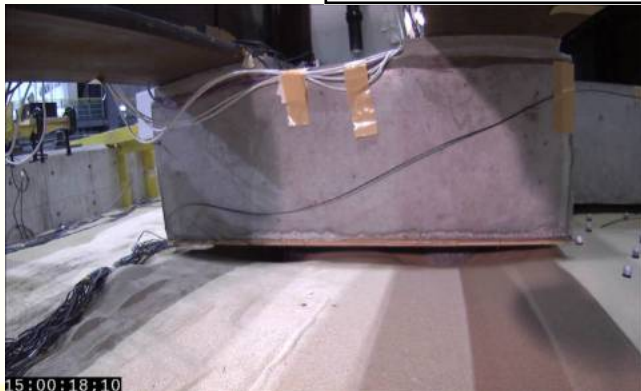
**Collapsed as predicted!**
