## SEISMIC VULNERABILITY OF LIMA CATHEDRAL, PERU

### ABSTRACT :

This paper presents results of the earthquake response analysis of this building carried out within a vulnerability study made at the Japan-Perú Earthquake Engineering and Disaster Mitigation Center (CISMID).

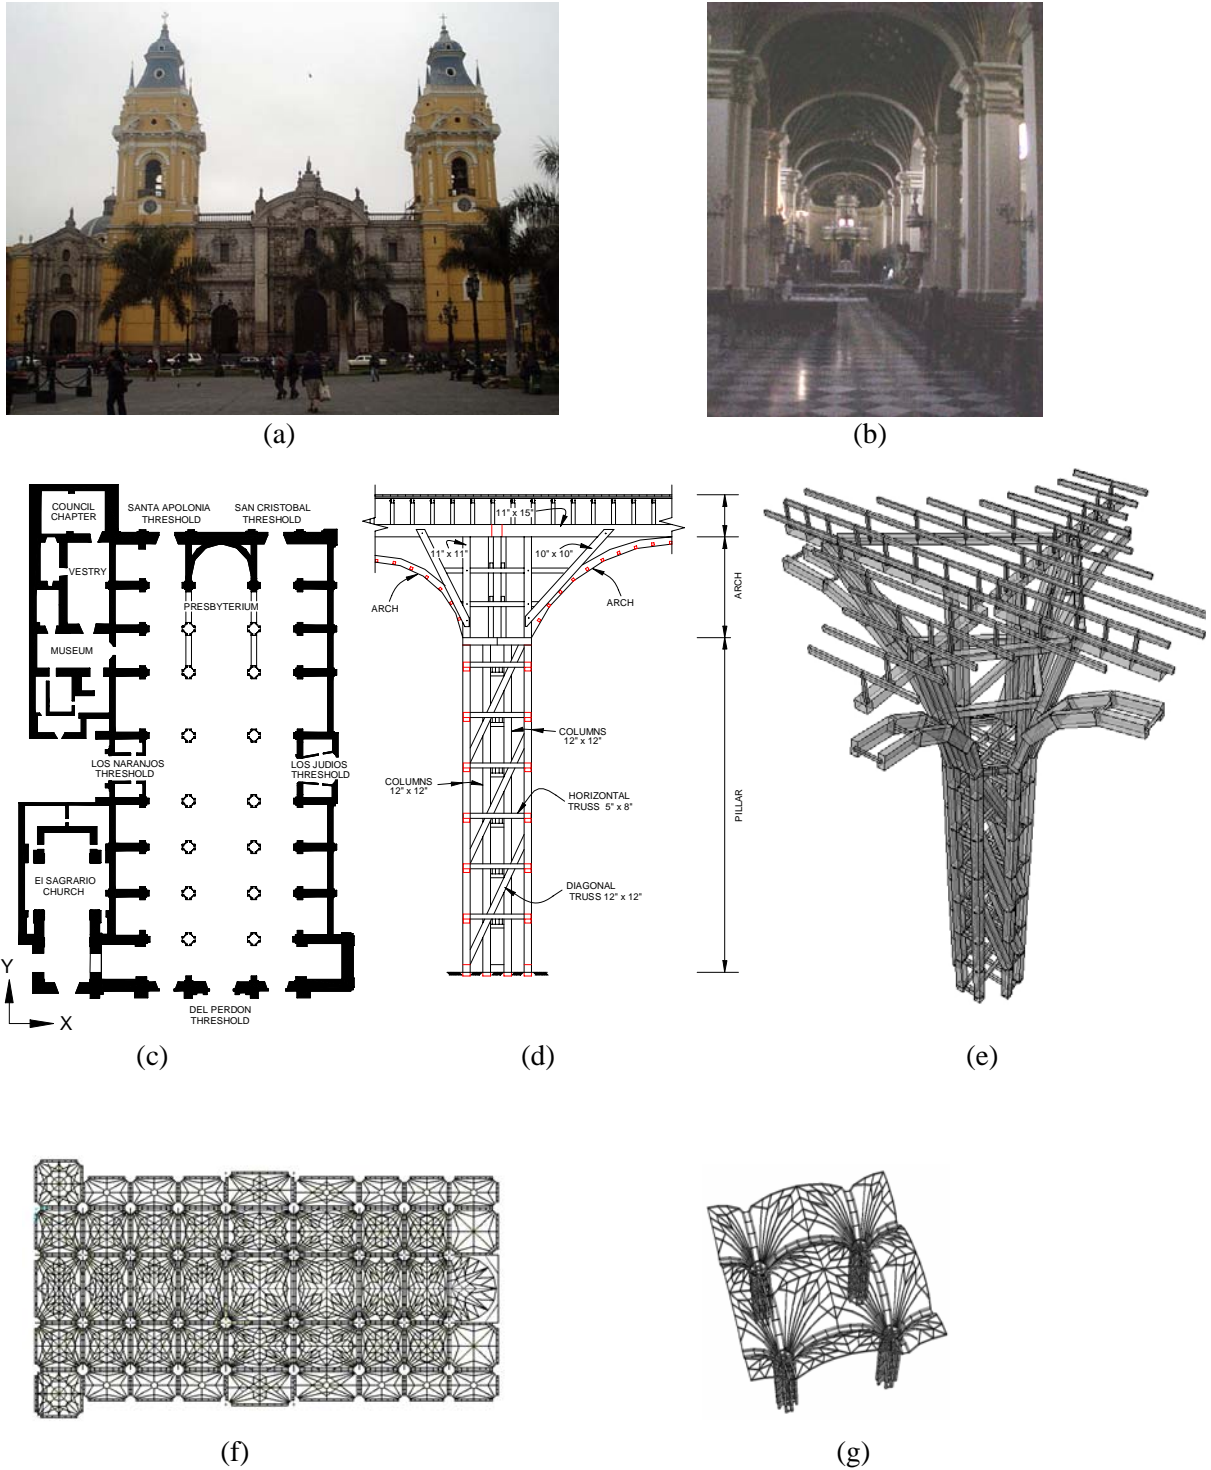
Fourteen 13m high wood framed pillars consist of eight columns, arranged in a cross shaped section, with horizontal and diagonal elements and an external cover made of wood, cane and plaster (figures 2b, 2d and 2e). These wood columns are not rigidly attached to the foundation; in some cases they penetrate up to 10cm into the foundation, but in others they only rest on top of it.

Figure 2 a) Front view of the Cathedral, b) Internal view of the structure c) Plan view of the structure, d) Elevation of wooden pillar, e) Isometric view of pillar, f) Plan view of wooden truss elements in vaults of building, g) Isometric view of a single vault.
