UNIVERSIDAD NACIONAL
DE INGENIERÍA

**CONFERENCIA INTERNACIONAL EN
INGENIERIA SÍSMICA**
Lima - Perú, 20, 21 y 22 de agosto del 2007

SEISMIC VULNERABILITY OF LIMA CATHEDRAL, PERU

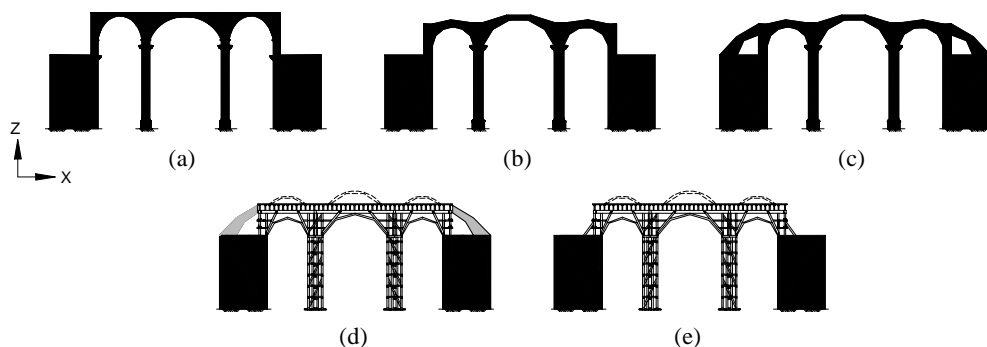
Figure 1a shows the original configuration, with masonry vaults which rested on oval arches. After the 1609 earthquake the Cathedral was reconstructed with full centered arches, Figure 1b. Figure 1c shows the flying buttresses which were added after the earthquake of 1687 to improve the lateral stiffness. After the great earthquake of 1746 the pillars and the roof structure were completely rebuilt in wood, Figure 1d. In 1898, a complete reconstruction of the roof structure (vaults, arches and horizontal frame) was carried out. For the first time in the history of the Cathedral, changes in the structure were not due to earthquakes but to the attack of termites and humidity, which had caused great deterioration of the wood elements. Figure 1e depicts the current configuration of the structure. The flying buttresses were removed after 1940.

Figure 1. Cross sections of the building showing structural changes in Cathedral
a) Until the earthquake of 1609, b) Before the earthquake of 1687, c) Before the earthquake of 1746, d) After the 1746 earthquake, e) Present configuration

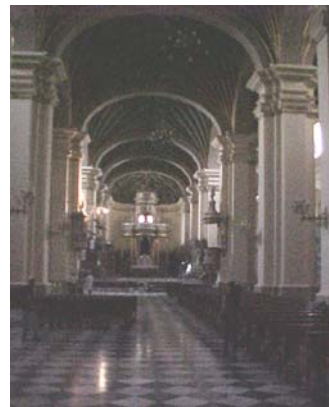
(b)

Fourteen 13m high wood framed pillars consist of eight columns, arranged in a cross shaped section, with horizontal and diagonal elements and an external cover made of wood, cane and plaster (figures 2b, 2d and 2e). These wood columns are not rigidly attached to the foundation; in some cases they penetrate up to 10cm into the foundation, but in others they only rest on top of it.

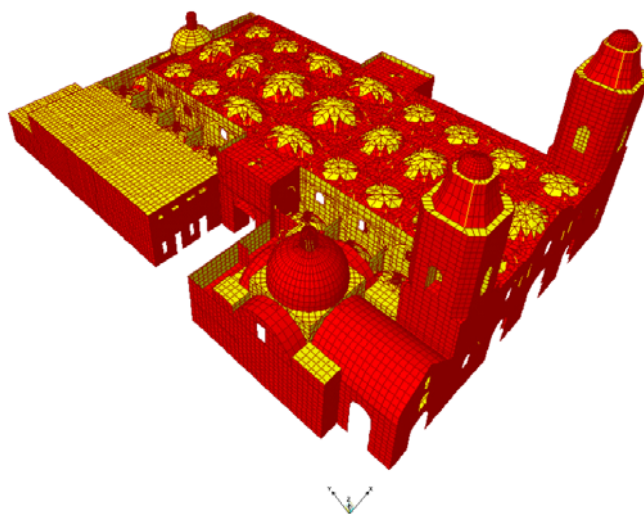
Figure 5. Mathematical model of Lima's cathedral

Figure 5 depicts the mathematical model for the analysis. 18,788 frame elements were used to represent wood elements from pillars, arches, vaults and the horizontal roof framework. The walls and the roof covers were modeled with 71,166 two dimensional shell elements.

The adequacy of the model was corroborated by its ability to predict not only the results of the microtremor tests but also to identify the portions of the structure which may be more severely stressed by earthquake loads, which are in agreement with the damage observed in past events.
