Working Group 2 B

Infrastructure: Lifelines, Roads

Water and Sewage Systems

2B-1: Survey of lifeline systems (water and sewage), road network and their environment, such as soil condition, supply area, and their Seismic vulnerability in study area.

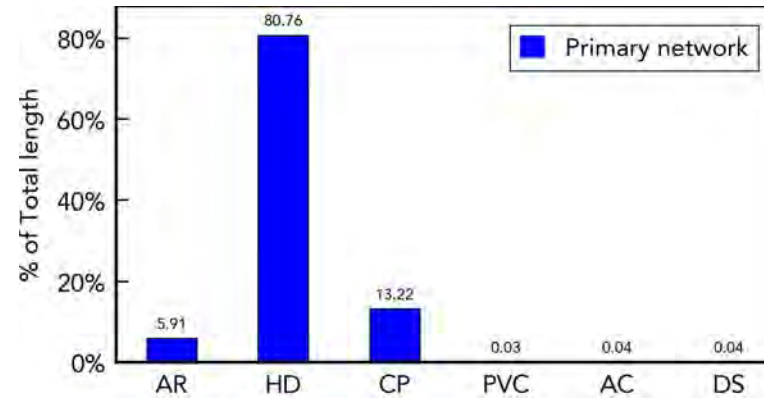
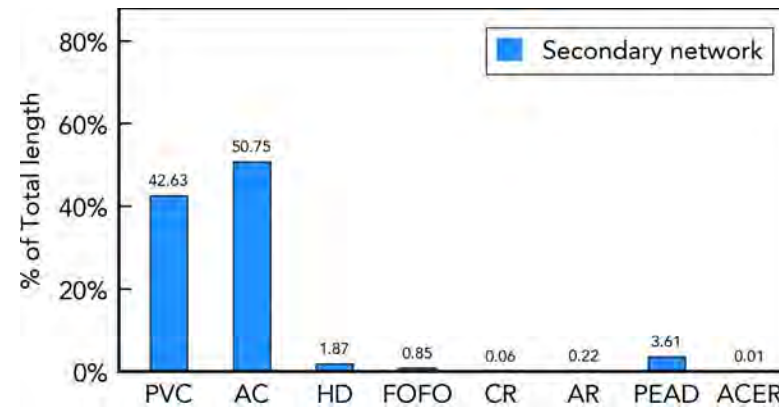
Pipeline material

Water Distribution Networks

- **Primary** distribution networks
- **Secondary** distribution networks

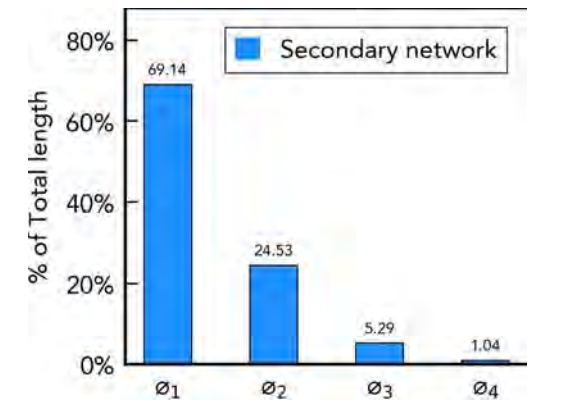
Note: Diameter ranges in mm : $\varnothing_1 < 150$, $150 \leq \varnothing_2 < 300$, $300 \leq \varnothing_3 < 450$ and $450 \leq \varnothing_4 \leq 600$

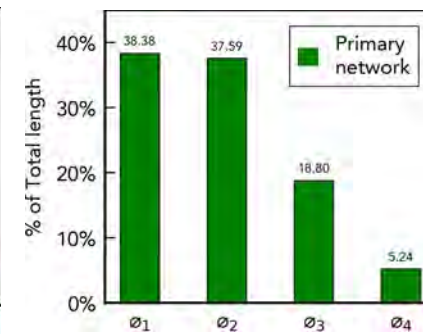
Pipeline diameter

Note: Diameter ranges in mm : \varnothing_1 < 500, $500 \leq \varnothing_2 < 1000$, $1000 \leq \varnothing_3 < 1500$ and $1500 \leq \varnothing_4 \leq 1800$

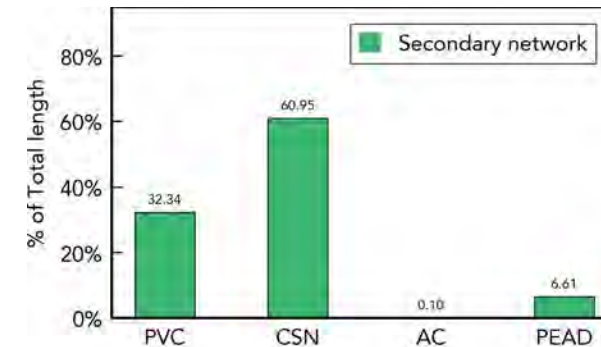
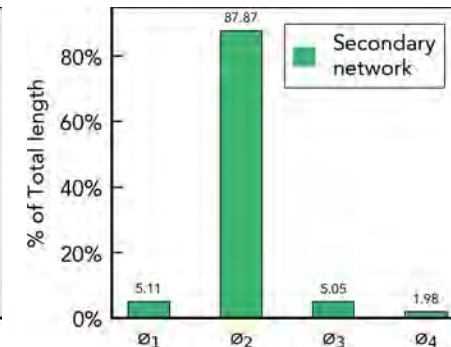
Note: Diameter ranges in mm : \varnothing_1 < 200, $\varnothing_2 = 200$, $200 < \varnothing_3 < 300$ and $300 \leq \varnothing_4 \leq 350$

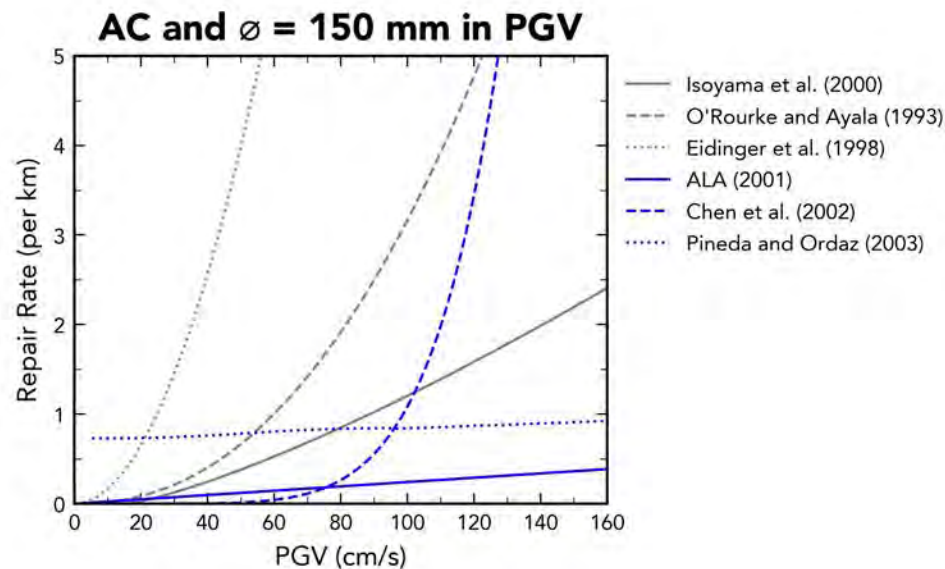
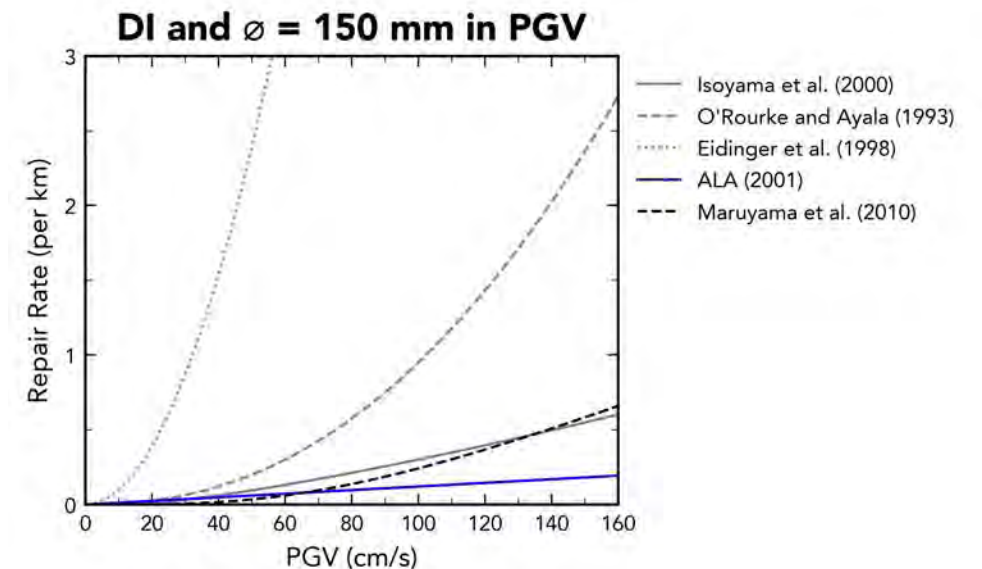
Comparative of Pipeline Fragility Functions

Damage Parameter (DP) to pipelines is commonly repair rate (RR), i.e. number of repairs per unit of length (usually in km).

Fragility Function	DP	IM	Typology	Information	Formulation
O'Rourke and Ayala (1993) NIBS (2004) FEMA (2020)	RR	PG V	Brittle or flexible pipes, for ductile pipelines (Steel, Ductile iron, and PVC) the value is multiplied by 0.3	Empirical (6 earthquakes) Used in HAZUS methodology	$RR \approx 0.0001 \cdot PGV^{2.25}$
ALA (2001)	RR	PG V	Material type (Unknown, Cast iron, Welded steel, Asbestos cement, Concrete, PVC, Ductile iron) Joint type Soil type Diameter (mm; small 100-300, large 300)	Empirical (12 earthquakes) Database: cast iron (38 data points) followed by steel (13), asbestos cement (10), ductile iron (9), and concrete (2).	$RR = K_1 \cdot 0.002416 \cdot PGV$

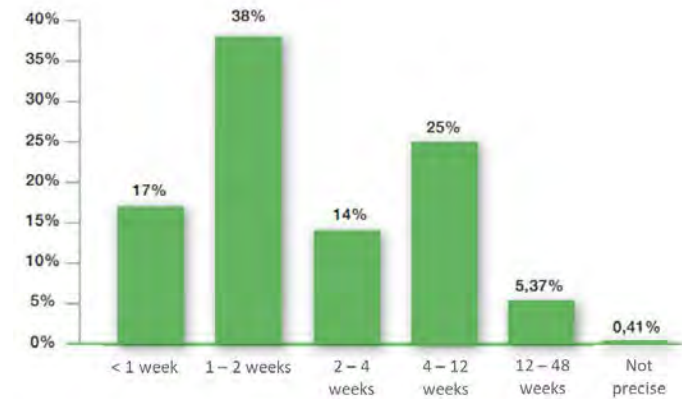
Water service restoration time

Information from surveys (Pisco, Chíncha, Ica and Cañete)

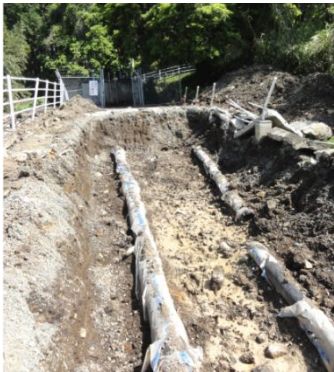
2016 Kumamoto EQ.
DIP ϕ 200 mm

The water supply system is an extremely important lifeline facility in modern society. **Recent earthquakes in Japan occasionally caused severe damage to water distribution pipelines**, and water supply was disrupted for weeks in the heavily affected area.
